## **Signal International**

### **Mississippi & Texas Facilities**

Signal International LLC  
SHAI Project No. 01-2008-12-09

Property Risk Assessment  
January 2009

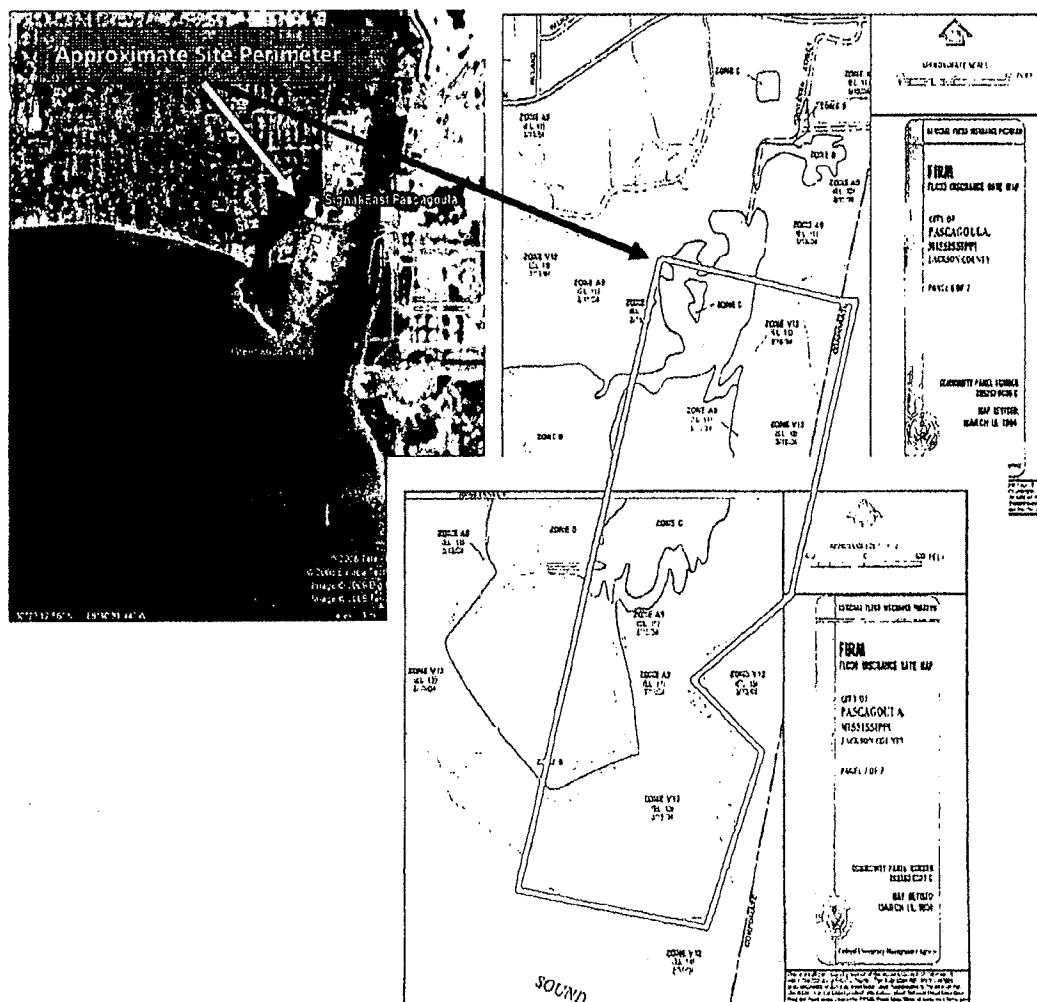
**Flood Zone Discussion - East Yard**601 Bayou Casotte Parkway  
Pascagoula, MS 3956830°20'36.97"N  
88°30'54.10"W

The FEMA maps below indicated that the site is in a combination of A, B, C and V Zones. These areas are located in marked elevations by the diagrams below as ranging between 10 – 13 feet (Note the C Zone elevation may be higher than 13 feet). The Administration, Offices, Warehouses 1, 2, & 3, and the Main Camp are located primarily in a C Zone according to the diagrams. It was indicated during the site survey that these areas did not have standing water following Hurricane Katrina. A surge level of 18 feet was recorded at the shore road to the west of this site during Hurricane Katrina. It was observed these areas are an uphill location from the shore yard, fabrication and repair areas of the yard which have standing water in the range of 5 feet during Katrina.

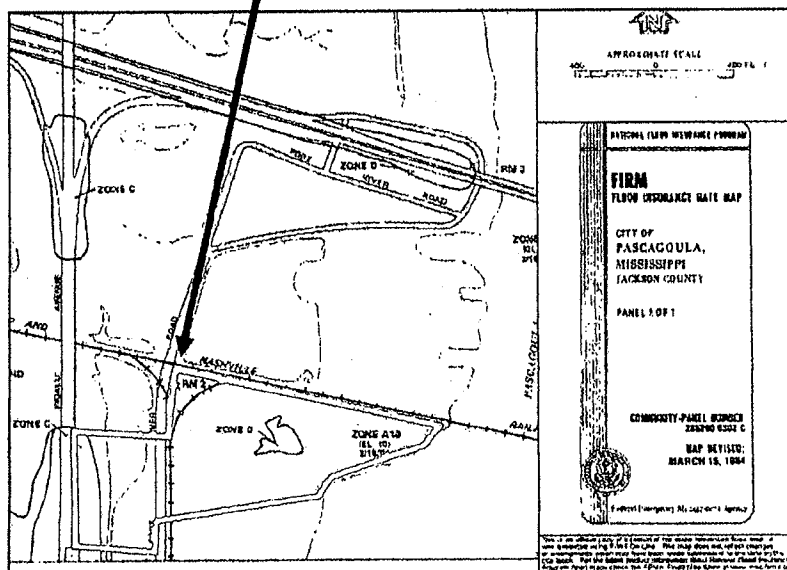
**Flood Zone Discussion West Yard**3500 Port Authority Road  
Pascagoula, MS 3956730°22'8.84"N  
88°34'8.87"W

The FEMA maps below indicated that the site is in a combination of A, B and C Zones. These areas are located in marked elevations by the diagrams below as 10 feet (Note the Band C Zone elevations are most likely higher than 10 feet). The Training Building is in a C Zone according to the diagram. It was indicated during the site survey that the Training Building did not have standing water following Hurricane Katrina. A surge level of 18 feet was recorded in this area during Hurricane Katrina. It was observed the Training Building is at higher elevation than the West Yard shore yard, fabrication and repair areas.

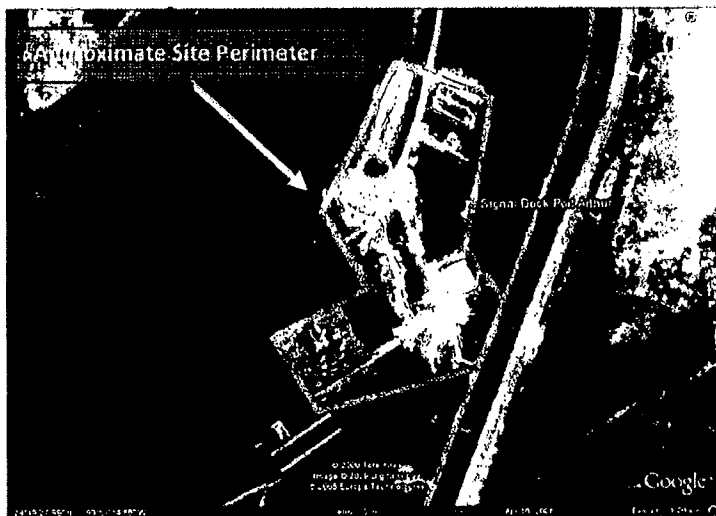
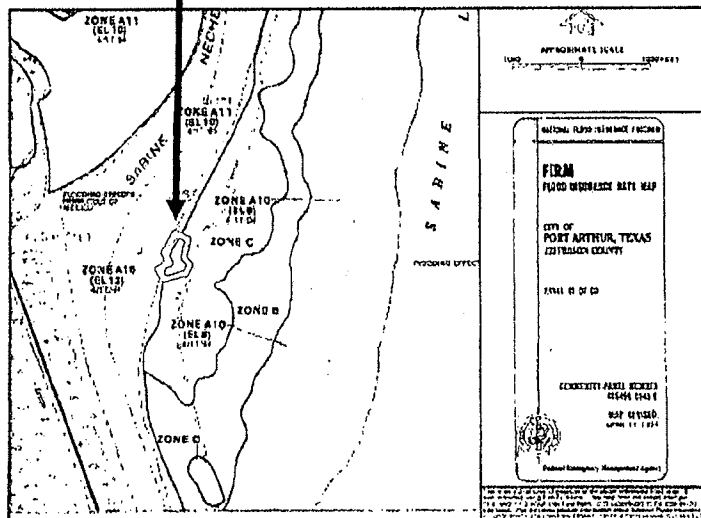
**Flood Zone Discussion Dock Yard**2500 Martin Luther King Blvd.  
Port Arthur, TX 7764029°49'30.09"N  
93°57'8.29"W

The FEMA maps below indicated that the site is in a combination of A and C Zones. These areas are located in marked elevations by the diagrams below as 10 -12 feet (Note the C Zone elevation may be slightly higher than 10 - 12 feet). It was indicated during the site survey that this area experience relatively little damage from standing water as a result of Hurricane Ike (2008). A surge level of approximately 15 feet was recorded in this area during Hurricane Ike. It was observed that this area overall is relatively flat with a slight slope to the Dry Dock.

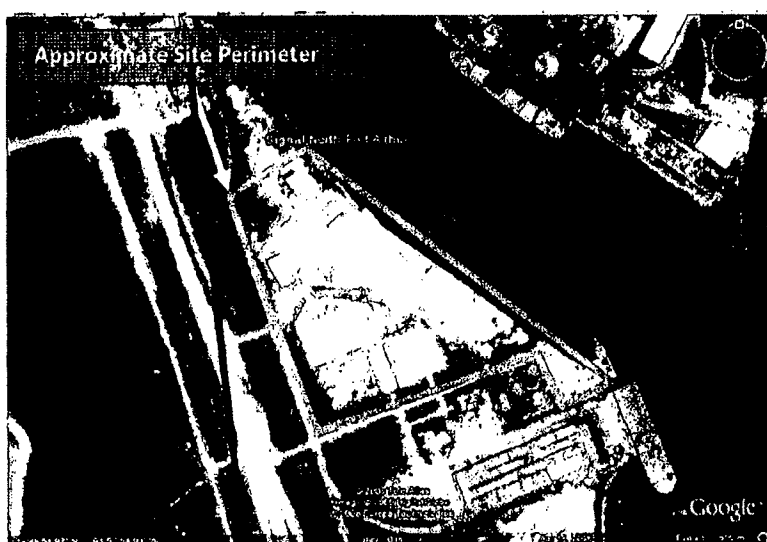
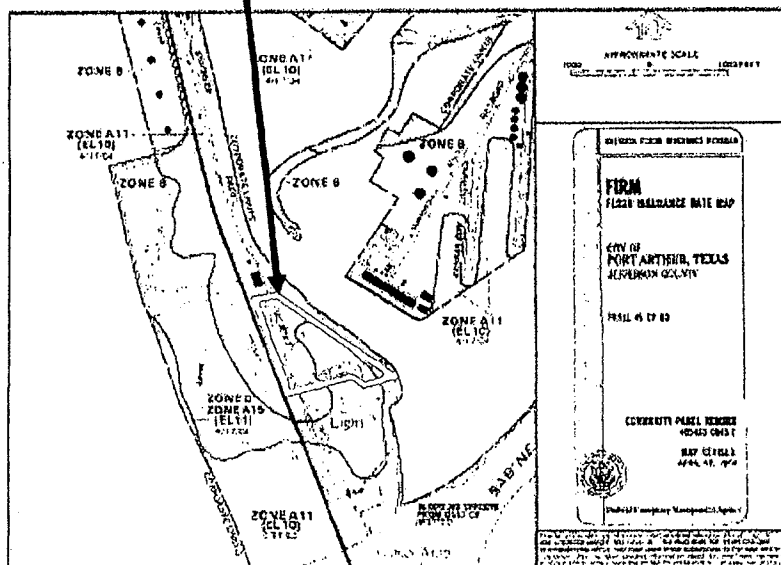
**Flood Zone Discussion North Yard**2350 South Gulfway Drive  
Port Arthur, TX 7764229°49'59.59"N  
93°58'1.44"W

The FEMA maps below indicated that the site is in a combination of A and B Zones. These areas are located in marked elevations by the diagrams below as 10 -11 feet. During the site survey this area experience damage from standing water as a result of Hurricane Ike (2008). A surge level of approximately 15 feet was recorded in this area during Hurricane Ike. It was observed that this area overall is relatively flat to the water shore area.

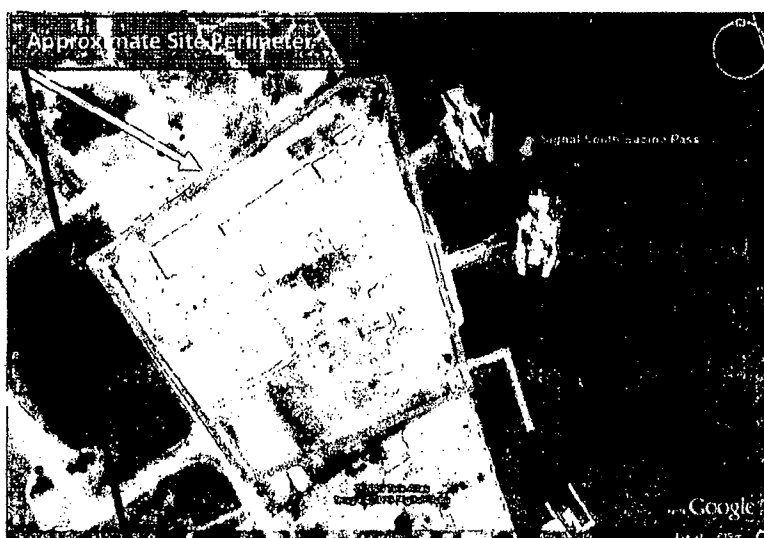
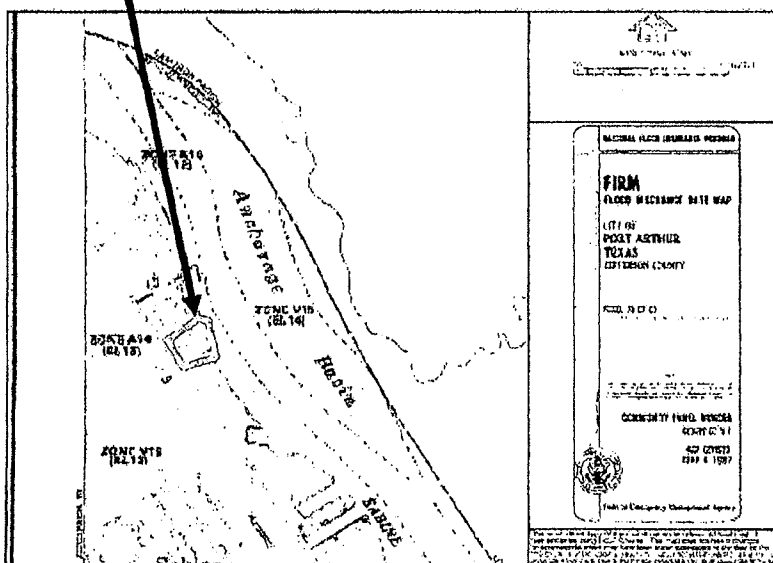
The FEMA maps below indicated that the site is in a combination of A and V Zones. These areas are located in marked elevations by the diagrams below as 12 -13 feet. During the site survey this area experience damage from standing water as a result of Hurricane Ike (2008). A surge level of approximately 15 feet was recorded in this area during Hurricane Ike. It was observed that this area overall is relatively flat to the water shore area.

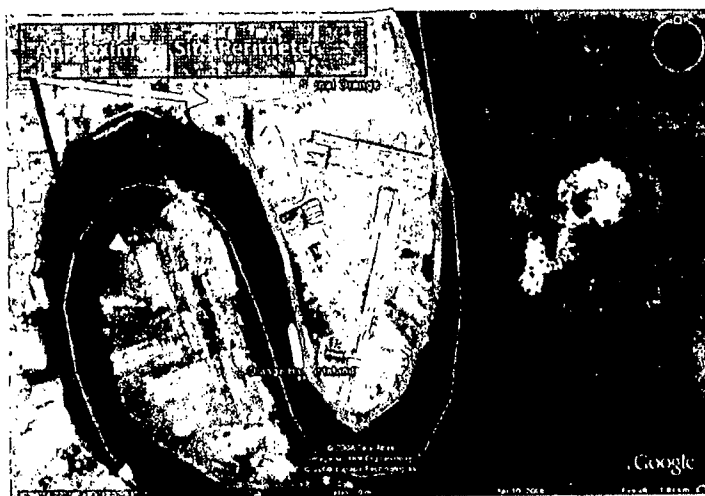
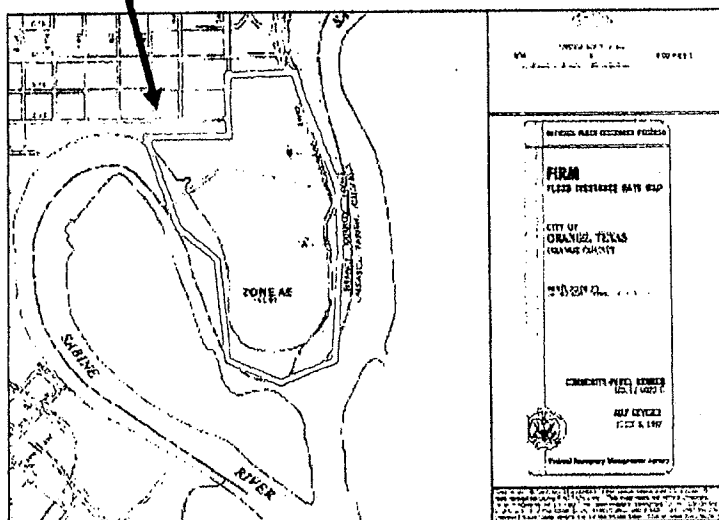
**Flood Zone Discussion Orange**91 West Front Street  
Orange, TX 7763030° 5'27.13"N  
93° 43'40.61"W

The FEMA maps below indicated that the site is in a combination of A Zone. This area is located in marked elevation by the diagrams below as 8 feet. It was indicated during the site survey that this area experience damage from standing water as a result of Hurricane Ike (2008) in the range of up to 8 feet above ground level. A water level above ground level was reported by the local media as 8 feet in general. Further south of this area surge levels of approximately 15 feet were recorded in the area of the Sabine River during Hurricane Ike. It was observed that this area overall is relatively flat with a slight with minimal slop to the water.

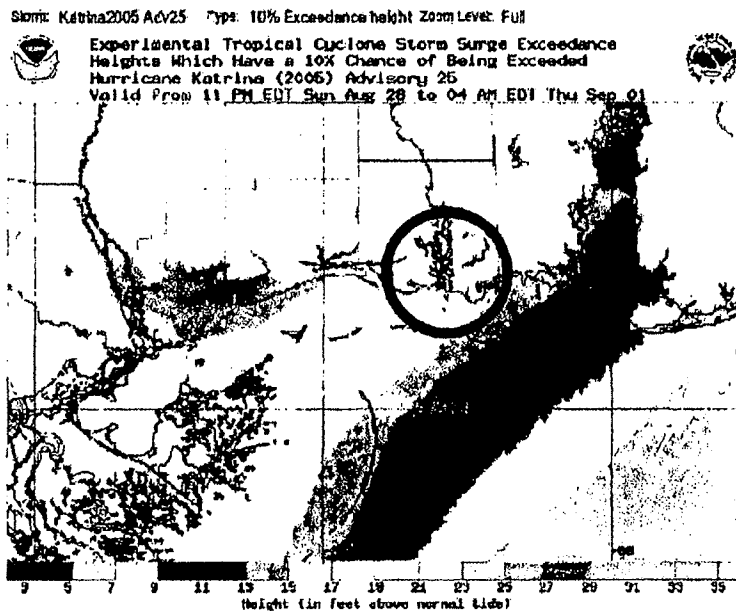
### Water Surge Discussion Pascagoula, MS

The following diagram indicates the predicted surge levels prior to Hurricane Katrina's arrival on shore. Note for that the surge prediction for this area ranged of 17ft to 19 ft is accurate.
